INDUSTRIAL SOLUTIONS USA

A Field Report

Secondary Containment – Repair

<p>Sprayed on containment liner had become breached. The damaged lining was removed and re-sprayed resulting in monolithic adhesion to existing lining.</p>
Industrial Customer:	Colonial Pipeline Co., Atlanta, GA Headquarters
Project Location:	Colonial Pipeline Co., Austell, GA Operations Juan Cazares, Associate Project Manager (PH) 770-819-3554
C&I Applicator:	V&V Commercial & Industrial Linings, LLC Archie Vega, Partner Charleston, SC (PH) 843-207-0533
Lining Formulation:	Concrete moisture cured sealer/primer. ISUSA – 544 (black), 100% solids polyurethane sprayed on lining
Lining Application System:	Rhino Linings MX-2300 Hi-Flow SprayCast System – low pressure and low temperature.

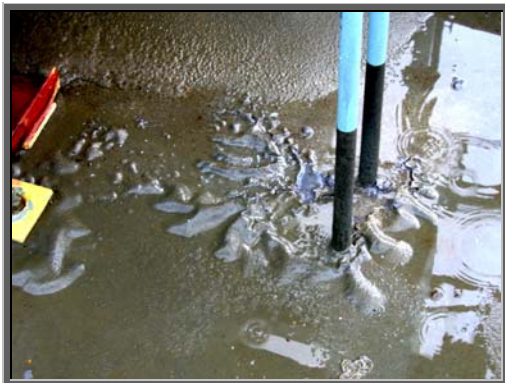
The portion of the sprayed on lining which had a breach was only a small area of the total lining. It was discovered another area adjacent to the breach exhibited delamination/poor adhesion to the concrete substrate. Colonial Pipeline wanted the area repaired quickly; they needed an applicator with a very portable application system that allowed the applicator to arrive on the job site with minimal notice. V&V Commercial & Industrial Linings was contacted to repair the small area with their Quick Spray system.

The previous lining had blistered due to contaminants left on the substrate which reacted with the sprayed on lining.

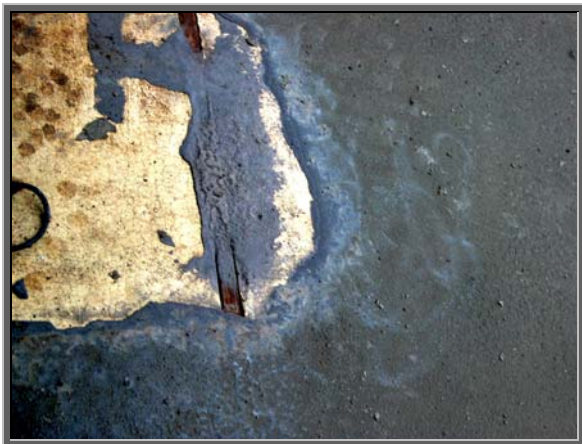
This is evidenced by the photo left that show the oils when a portion of the failed lining was removed.
